District Engineer's Report

Residential Community Drainage System

St Lucie West Services District

May, 2012

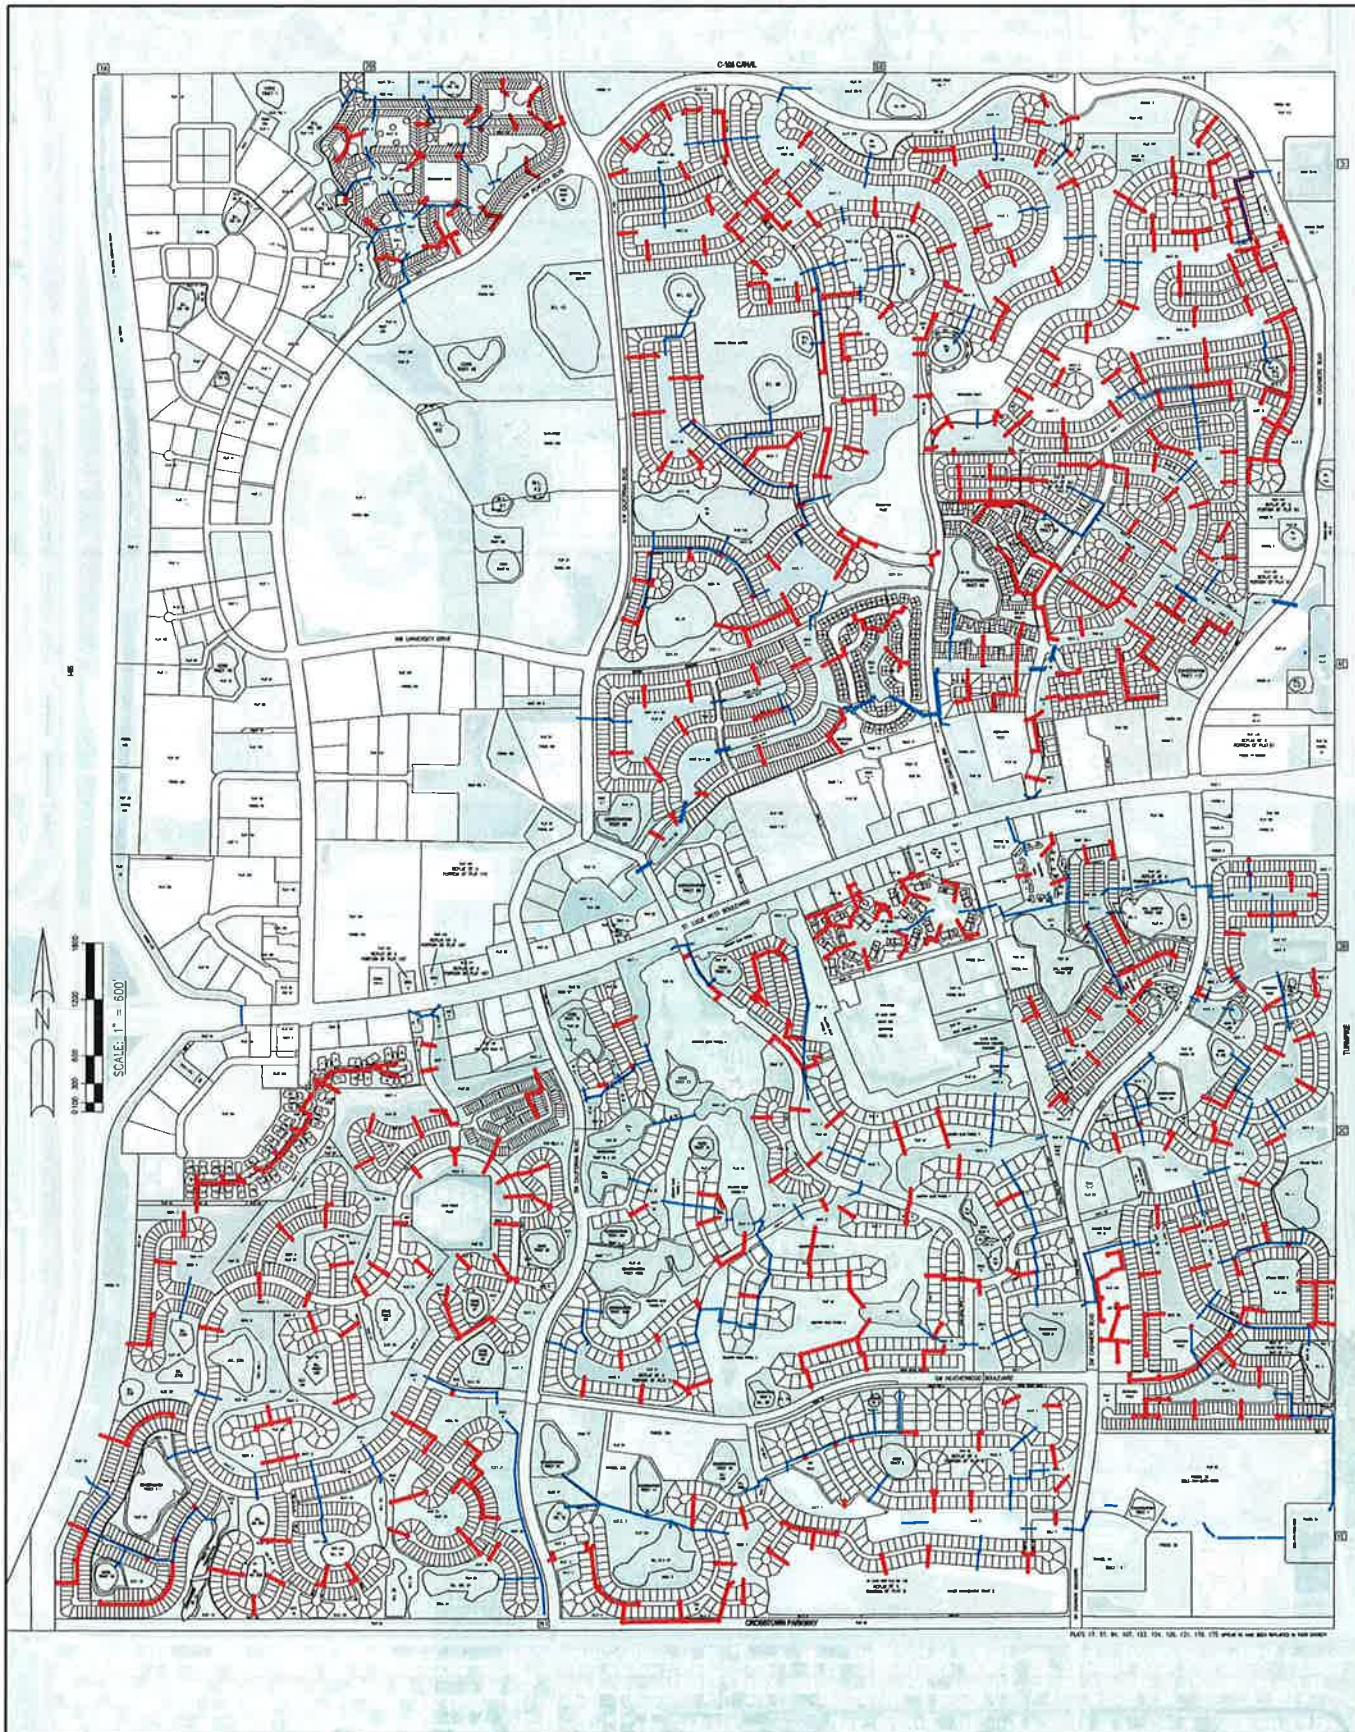
EXHIBIT 6

District Maintenance Responsibility Map

MAINTENANCE RESPONSIBILITY

— DISTRICT
— HOA
